Full Mouth Rehabilitation of a Patient with Severely Worn Dentition and Reduced Occlusal Vertical Dimension: A Clinical Report

Keywords: Attrition, Full mouth rehabilitation, Occlusal vertical dimension, Wear.

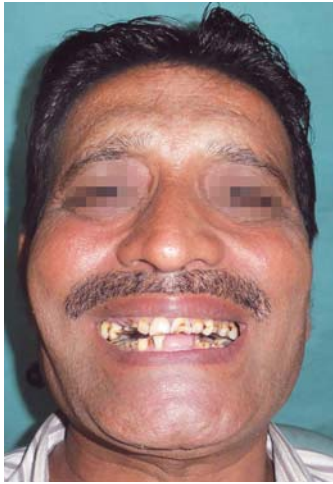
Fig. 1A: Pretreatment profile view

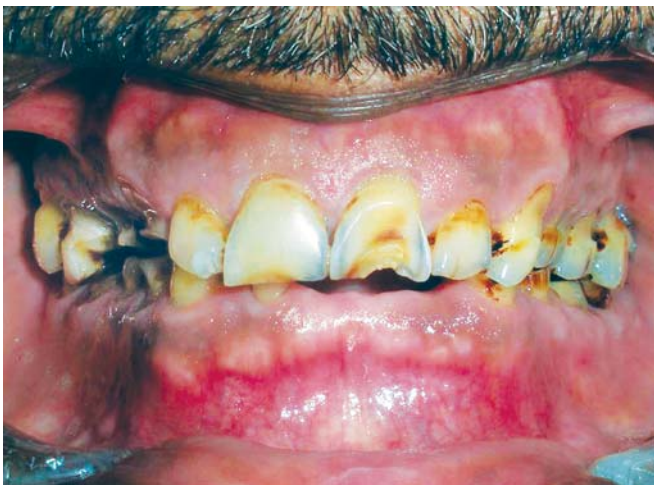
A 40-year-old male patient came to the Department of Prosthetic Dentistry with a chief complaint of anterior teeth wear and requested esthetic enhancement (Fig. 1A). Clinical and radiographic examinations revealed generalized severe attrition and cervical abrasion (Figs 1B and C). More aggressive attrition was seen in mandibular dentition and the maxillary teeth showed superruption; therefore the occlusal plane appeared to be irregular and at a lower level. Mandibular central incisors and left lateral incisor were missing. TMJ function was normal with no clicking or tenderness. The patient denied of having any parafunctional habit but the relatives pointed out bruxism and night grinding. The patient gave history of brushing teeth with

Fig. 1B: Pretreatment frontal view of teeth in occlusion

an abrasive tooth powder with a hard bristle brush. After complete diagnostic evaluation, treatment plan was designed to establish the occlusal plane at a proper level and full mouth rehabilitation of the maxillary and mandibular natural dentition with metal-ceramic restorations after endodontic treatment and implant supported FDP in place of the missing mandibular incisors. The patient was instructed about proper brushing technique with a less abrasive toothpaste and soft bristle brush.

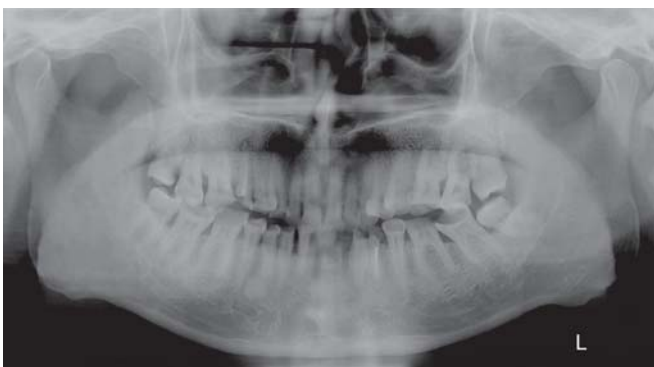
Fig. 1C: Pretreatment radiograph

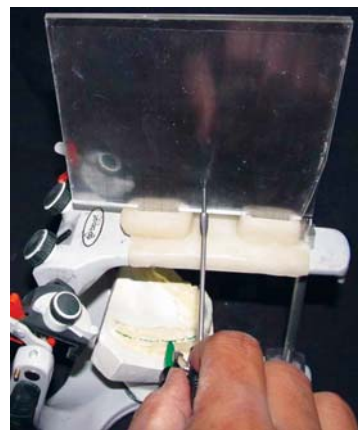
Fig. 2A: Occlusal plane determined using Broderick occlusal plane analyzer

Study casts were obtained and mounted on a semiadjustable articulator (Bio-Art, Sao Carlos, Sao Paulo, Brazil) using centric relation occlusal record and a facebow transfer. As revealed from diagnostic mounting, there was insufficient height of several teeth. Endodontic therapy of all natural teeth and crown lengthening procedure of several maxillary and mandibular teeth was carried out for long-term functional and esthetic restorations of the teeth. Maxillary left second and third molars showed poor prognosis and were advised for extraction. A centric relation anterior index from pattern resin (GC Corporation, Tokyo, Japan) was fabricated to maintain the centric relation position at the desired OVD during teeth preparation phase. Mock preparation and diagnostic wax-up of anterior teeth was accomplished. By using Broderick's occlusal plane analyzer, occlusal plane was determined on the mandibular cast (Figs 2A and B) and a baseplate wax (modeling wax; Deepti Dental Products, Ratnagiri, India) occlusal plane index was made on this established occlusal plane.¹⁸ The occlusal plane index was mounted in place of maxillary cast and used to prepare diagnostic wax-up of mandibular posterior teeth at the established occlusal plane (Fig. 2C). Maxillary posterior wax-up was completed using the mandibular wax-up (Fig. 2D). Vinyl polysiloxane putty (Elite HD+, Zhermack SpA, Badia Polesine, Italy) templates were made of the diagnostic wax-up. Preparation of the maxillary and mandibular teeth was performed using the centric relation index to confirm clearance. Postcore restorations with glass fiber posts (DT Light-Post Illusion, Bisco Inc, Illinois, USA) was cemented with maxillary right canine, first and second premolars (Fig. 3). Core build of maxillary and mandibular teeth was accomplished with composite resin (Matrix, Medicept Dental, Middlesex, UK). By using putty templates of the diagnostic wax-up, provisional restorations were fabricated from bis-acryl resin-based provisional restorative material (Luxatemp Star,

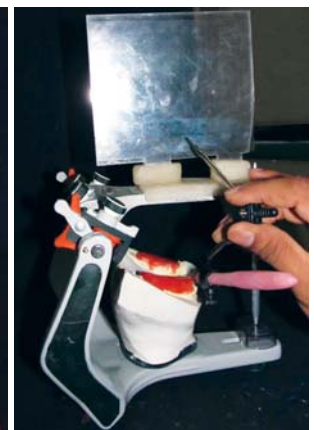
Fig. 2B: Occlusal plane carved on baseplate wax block

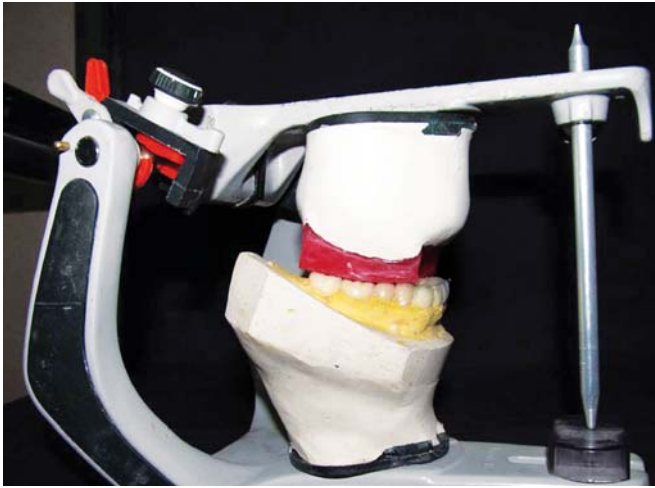
Fig. 2C: Occlusal plane index mounted and mandibular diagnostic wax-up accomplished

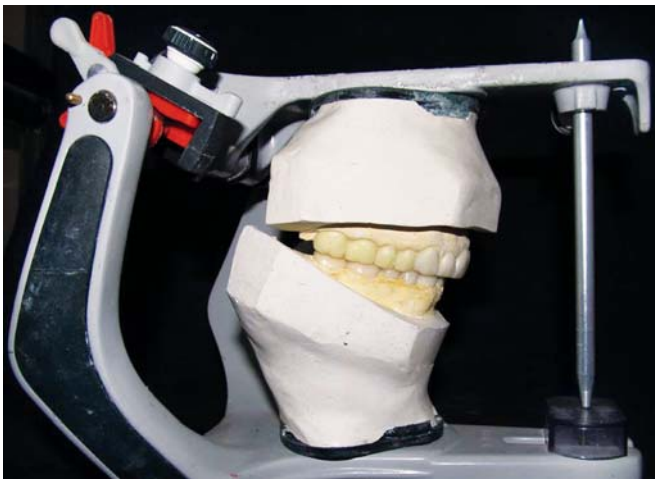
Fig. 2D: Maxillary posterior wax-up

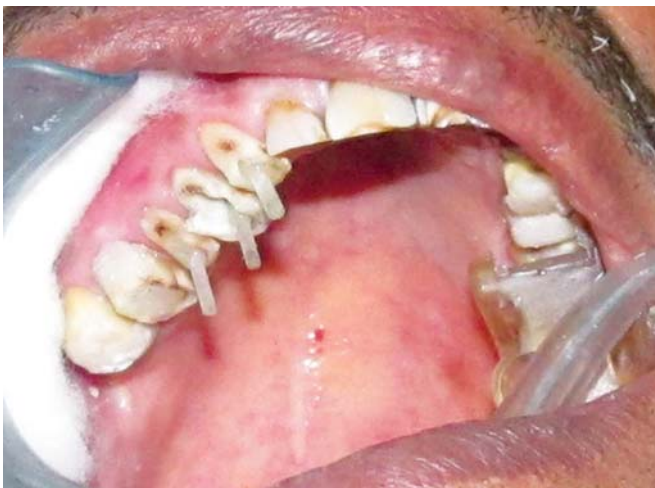
Fig. 3: Post-core with glass fiber posts in maxillary right canine, first and second premolars

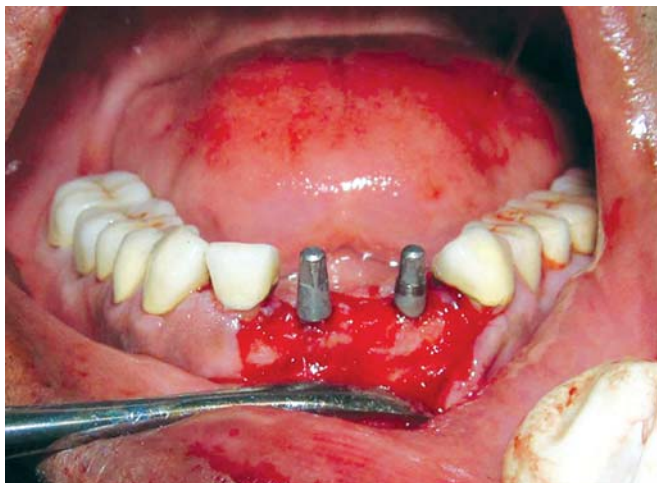
Fig. 4: Two one-stage implants in place of mandibular right central incisor and left lateral incisor

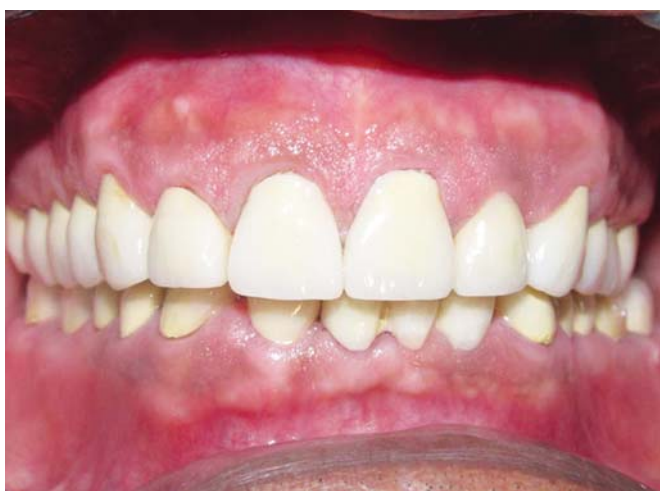
Fig. 5A: Definitive restorations in left lateral excursion

Once the provisional restorations were equilibrated and esthetics and phonetics were deemed satisfactory, an occlusal bite record was made of the maxillary and mandibular provisional restorations. Impressions of the provisional restorations made, casts were mounted using facebow and occlusal bite record of the provisional restorations against each other. A custom incisal guide table was fabricated to reproduce the anterior guidance established with the provisional restorations. The protrusive path and lateral excursions were recorded in putty on the flat guide table by movement of the articulator pin. A vinyl polysiloxane putty (Elite HD+, Zhermack SpA, Badia Polesine, Italy) index was made from the provisional models to duplicate the provisional restorations in definitive restorations. Patient used these provisional restorations for 3 months and was evaluated weekly for occlusion, wear and TMJ tolerance. After 3 months, the provisional restorations were removed and teeth were modified to make the definitive impressions with vinyl polysiloxane impression material (Elite HD+, Zhermack SpA, Badia Polesine, Italy) in a custom acrylic tray. Vinyl polysiloxane bite registration paste (Exabite II NDS, GC America INC, Alsip, Illinois, USA) was injected between anterior teeth while keeping the posterior provisionals in place. Two posterior bite registration records were obtained by placing the anterior bite record and keeping provisional restorations on one side. In this way three individual bite registration records (one of anterior sextant and two of posterior sextants) were obtained while maintaining the OVD achieved by provisional restorations. After recording the facebow relation, definitive casts were mounted on semiadjustable articulator. The wax-up for the definitive restorations were prepared using cut back technique using custom incisal guide table and putty index of provisional casts, and definitive metal-ceramic restorations were fabricated. Unglazed metal-ceramic definitive restorations were tried in the patient's mouth and evaluated for esthetics, occlusion and phonetics. After complete satisfaction of the patient, the restorations were glazed and cemented using glass ionomer luting cement (GC Gold Label, GC Corporation, Tokyo, Japan). Osteotomy was performed in the region of mandibular right central incisor and left lateral incisor to receive two one-stage implants (Fig. 4). Implant supported provisional FDP was prepared and cemented on the implants. The provisional FDP was replaced with a definitive metal-ceramic FDP after 3 months of evaluation (Fig. 5A). Posterior disclusion on protrusion and canine-guided occlusion on lateral excursion was achieved in the

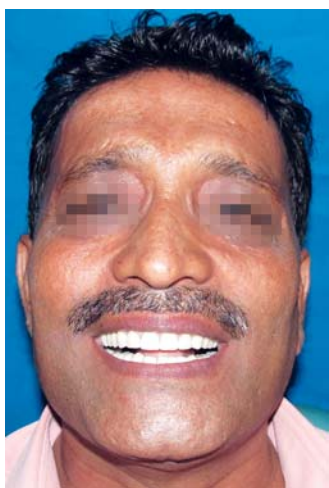
Fig. 5B: Post-treatment profile view

definitive restorations. The patient was given oral and written oral hygiene instructions and recalled for periodic examination. Patient was satisfied with the esthetic and functional outcome of the treatment after 1 year follow-up (Figs 5B and C).

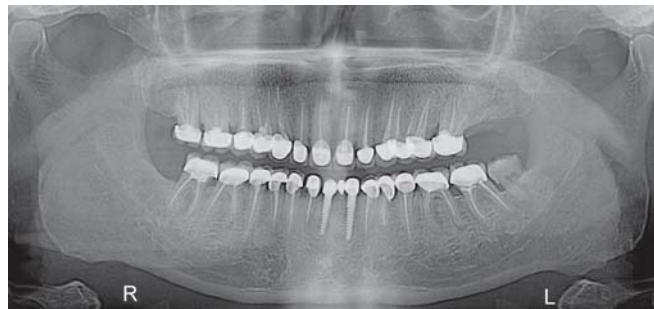
Fig. 5C: Post-treatment radiograph
